Contract #: 04-0120F4Cty: SF/ALA Rte: 80 PM: 13.2/13.9File #: 99.28**WELDING INSPECTION REPORT****Resident Engineer:**Siegenthaler, Peter**Address:** 333 Burma Road**City:** Oakland, CA 94607**Report No:** WIR-025976**Date Inspected:** 30-Jun-2011**Project Name:** SAS Superstructure**OSM Arrival Time:** 700**Prime Contractor:** American Bridge/Fluor Enterprises, a JV**OSM Departure Time:** 1900**Contractor:** Zhenhua Port Machinery Company, Ltd (ZPMC) Chanxing Island**Location:** Shanghai, China**CWI Name:** N / A**CWI Present:** Yes No**Inspected CWI report:** Yes No N/A**Rod Oven in Use:** Yes No N/A**Electrode to specification:** Yes No N/A**Weld Procedures Followed:** Yes No N/A**Qualified Welders:** Yes No N/A**Verified Joint Fit-up:** Yes No N/A**Approved Drawings:** Yes No N/A**Approved WPS:** Yes No N/A**Delayed / Cancelled:** Yes No N/A**Bridge No:** 34-0006**Component:** OBG Segment**Summary of Items Observed:**

BLASTING INSPECTION**Segment 14W**

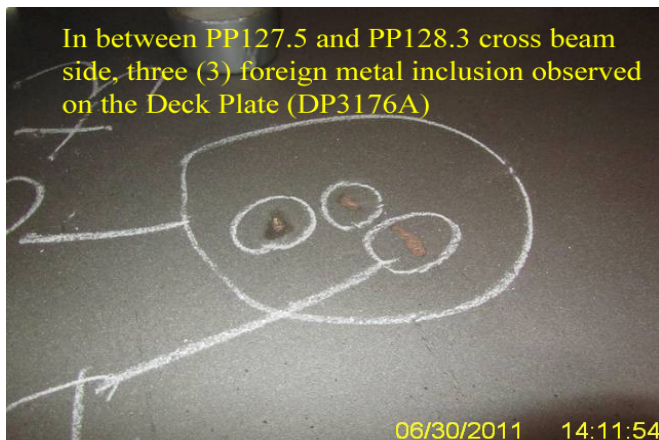
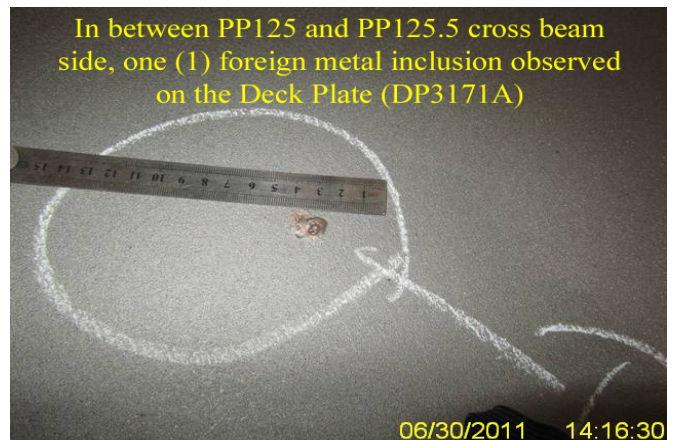
1. In between PP127.5 and PP128.3 cross beam side, three (3) foreign metal inclusion observed on the Deck Plate (DP3176A). Areas were taped prior to blast and paint. See the attached picture.
2. In between PP125 and PP125.5 cross beam side, one (1) foreign metal inclusion observed on the Deck Plate (DP3171A). Areas were taped prior to blast and paint. See the attached picture.
3. At PP 128.3 cross beam side near SA3416C, base metal repair need to be done on Deck Panel Diaphragm.
